Forest Hills School District Anderson High School Pool Facility Report

June 2, 2026

**FOREST HILL SCHOOL DISTRICT
ANDERSON HIGH SCHOOL
NATATORIUM ASSESSMENT**

GPR Survey Results	Exhibit
Anderson HS Swimming Pool 7560 Forest Road Cincinnati, Ohio	1

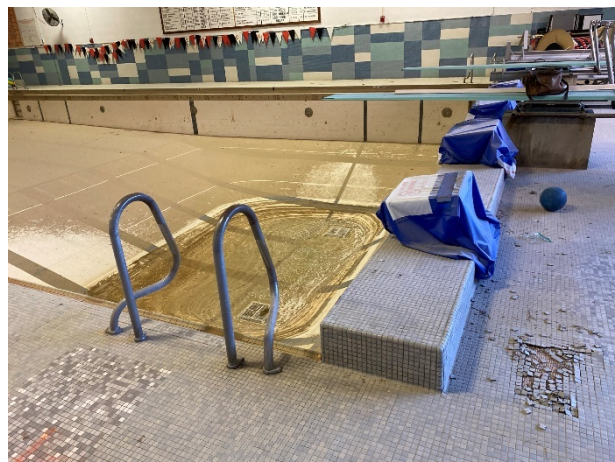
- 60+ year old facility - The existing natatorium is a 60+ year old facility that was constructed in the early 1960's and has been in operation most of that time. The facility is located on the lower level of the High School under the main Gymnasium. The pool exits on-grade to the exterior on the east side of the building. Existing locker rooms are located to the south. The north and west sides are below grade with the grade sloping away on the north side. Limited as-built drawings were available for the facility. Existing structural drawings for the pool were not available. Assumptions were made regarding the construction of the pool, including foundation walls, for the purposes of the study. Further investigation would be needed to determine actual construction details.

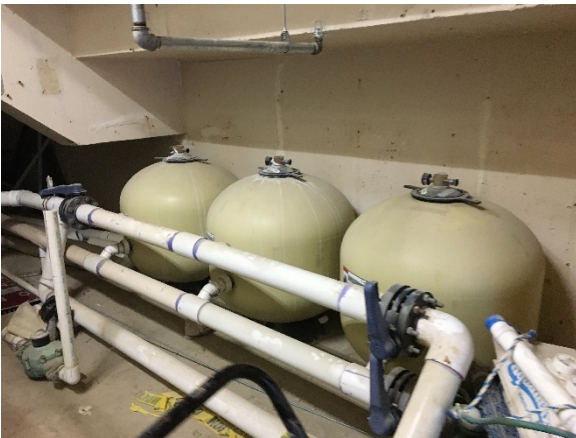
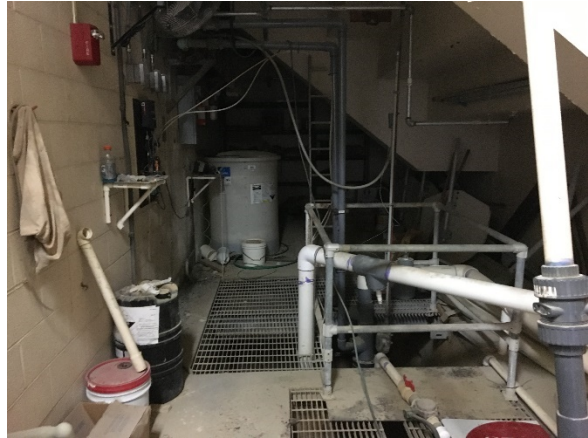
- Pool systems and equipment are past the end of their useful life
 - o Pool pumps and filtration system are outdated and in certain instances no longer operational. Refer to the attached drawings for further details and comments.
 - o Electrical Services
 - Field investigation revealed that the existing equipment is served from panel PP-1 located in the west side storage room beneath the viewing stand and a local panel (no nomenclature) located in the pool filtration room.
 - o Lighting Services
 - Field investigation revealed that the lighting is served from LP1-1 located on the natatorium west wall.
 - Field investigation revealed that the current lighting fixtures are minimally operable and are at or near the end of their serviceable life.
 - o Low Voltage Services
 - Field investigation revealed little to no “connectivity” to the natatorium equipment or general area.

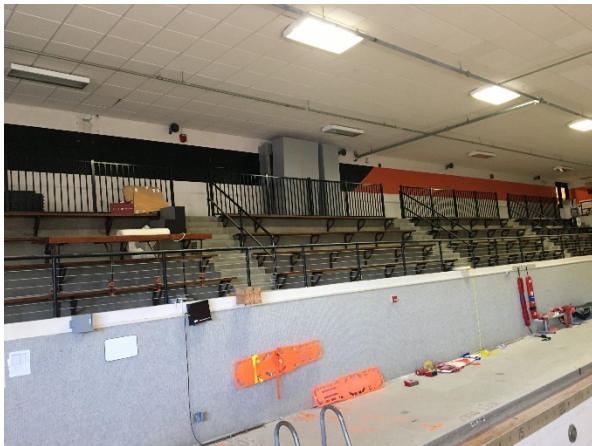
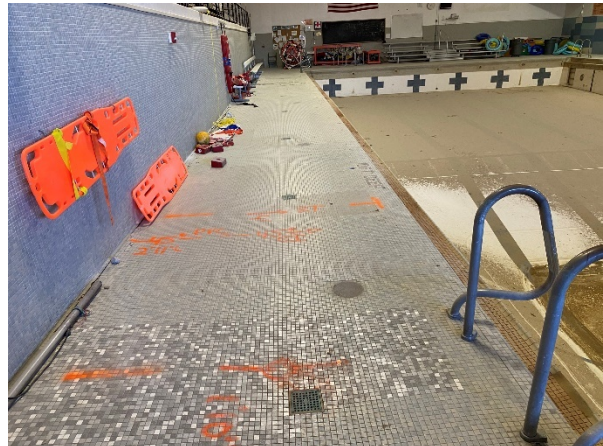
- o Pool deck – The existing pool deck has a ceramic mosaic tile finish that is cracking and spauling in certain locations. The tile will need to be removed and replaced due to the extents of the construction work.

- o Seating & railing – The existing seating consists of wood benches moutned to riser of cast-concrete tiers. Railings are painted metal with cable rails.

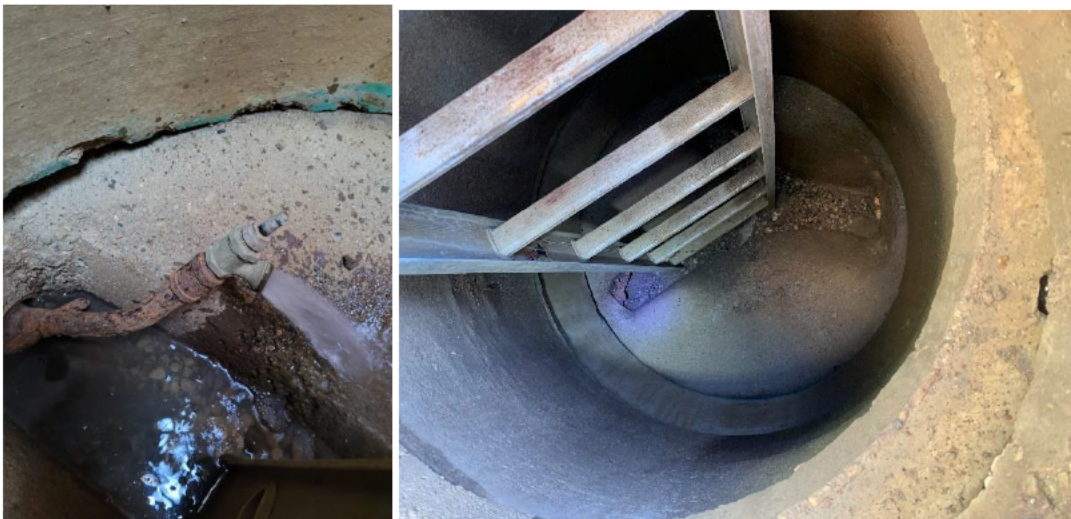
The investigation started at STM MH-3. A release valve exists at the bottom of STM MH-3 that is connected to the deck drains and scum gutters. This was confirmed by dumping water in both the deck drains and scum gutters noting the flowing water. The drain tile from the north side of the building is also tied into STM MH-3. Video was recorded on both the lines from the STM MH-3. There appears to be debris partially blocking the line into the building around 20' and the drain tile seems to be capped about 4' in.

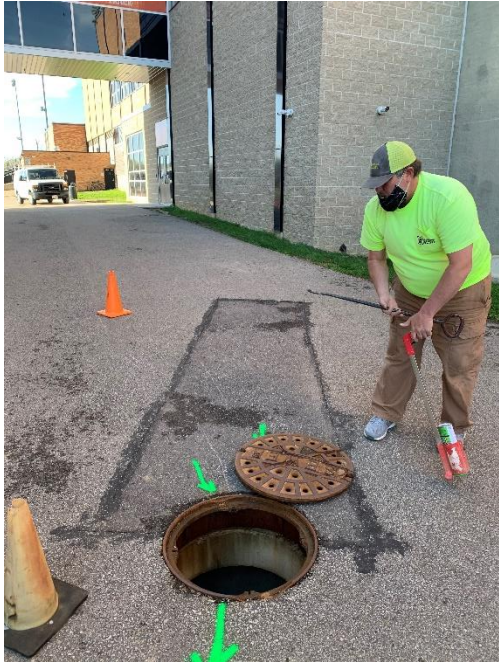
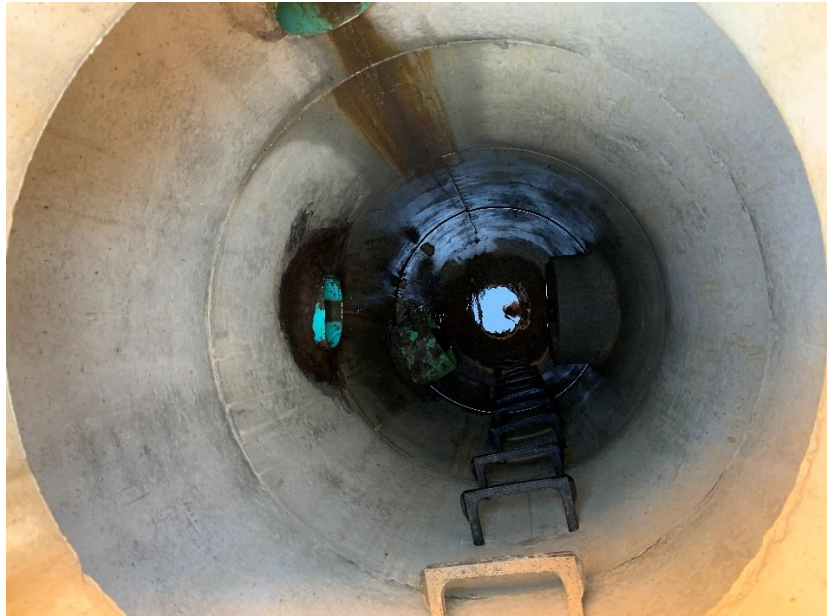
Storm lines from STM MH-1 were recorded both toward the trench drain at the building entrance. Both lines appeared to be clear but there was some difficulty getting the camera passed a pipe fitting near the building entrance. Lines from this manhole were also inspected for any future stubs as indicated by maintenance personnel. No indication was found.

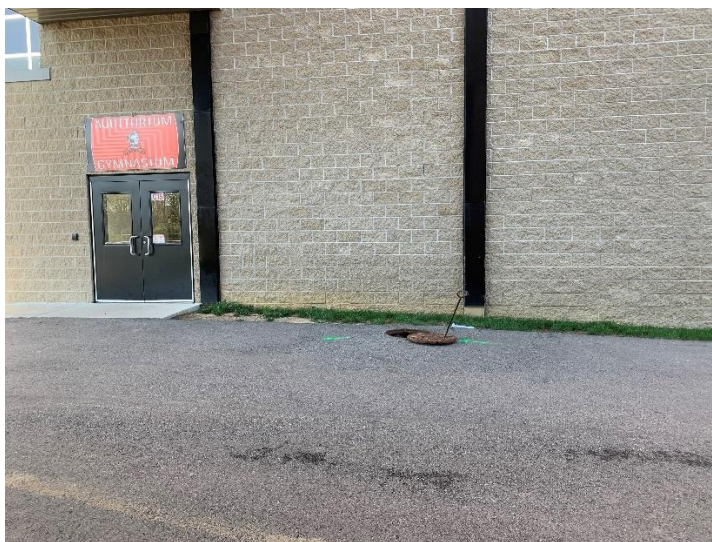
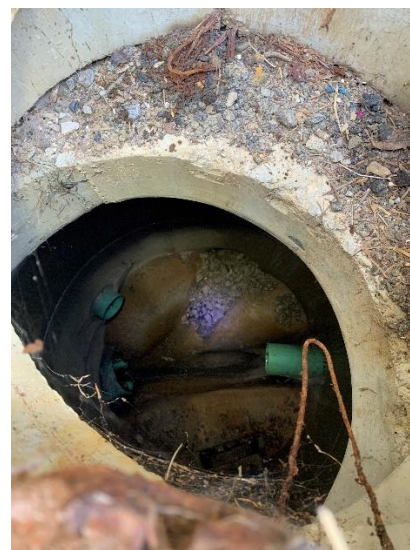
Sanitary Lines from SMH-1 were video recorded. Both the south west and west lines have been capped and abandoned as indicated in the post construction site plan. The north west line (SAN-2) was recorded until a fitting that could not be passed just past the elevator near the trench drain as indicated in the current and overlaid plumbing plans. Lines from this manhole were also inspected for any future stubs as indicated by maintenance personnel. No indication was found.

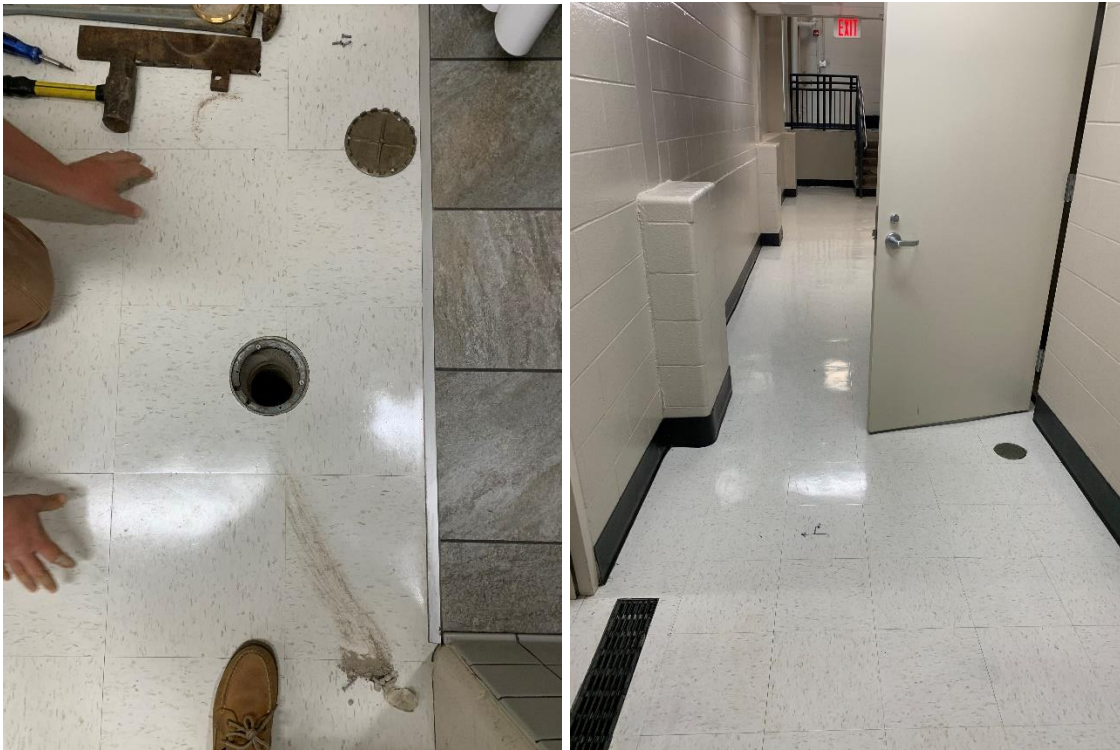
The sanitary line (SAN-2) installed during the renovation as indicated in the plumbing plans was recorded from a clean out in the female locker rooms to the trench drain in front of the elevator door.

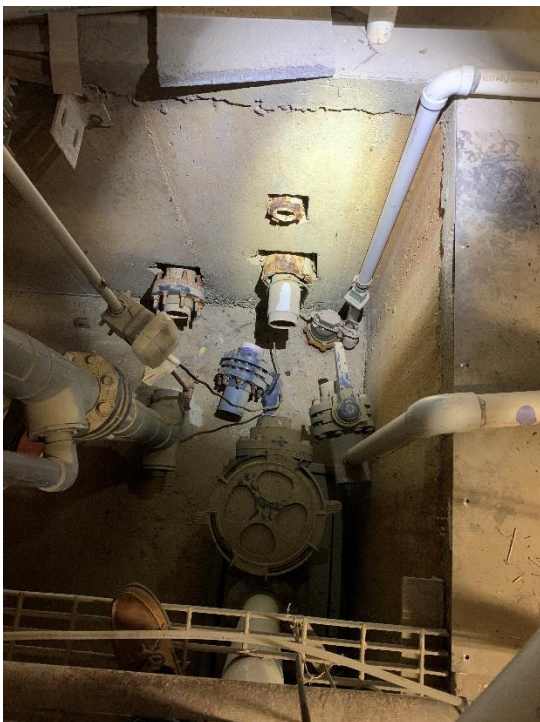
Sanitary lines from the pool maintenance room could not be accessed. SAN-1 as indicated in the original plumbing drawings was not found and or could not be accessed. Maintenance personnel indicated they thought it had not been installed or has been capped / abandoned.

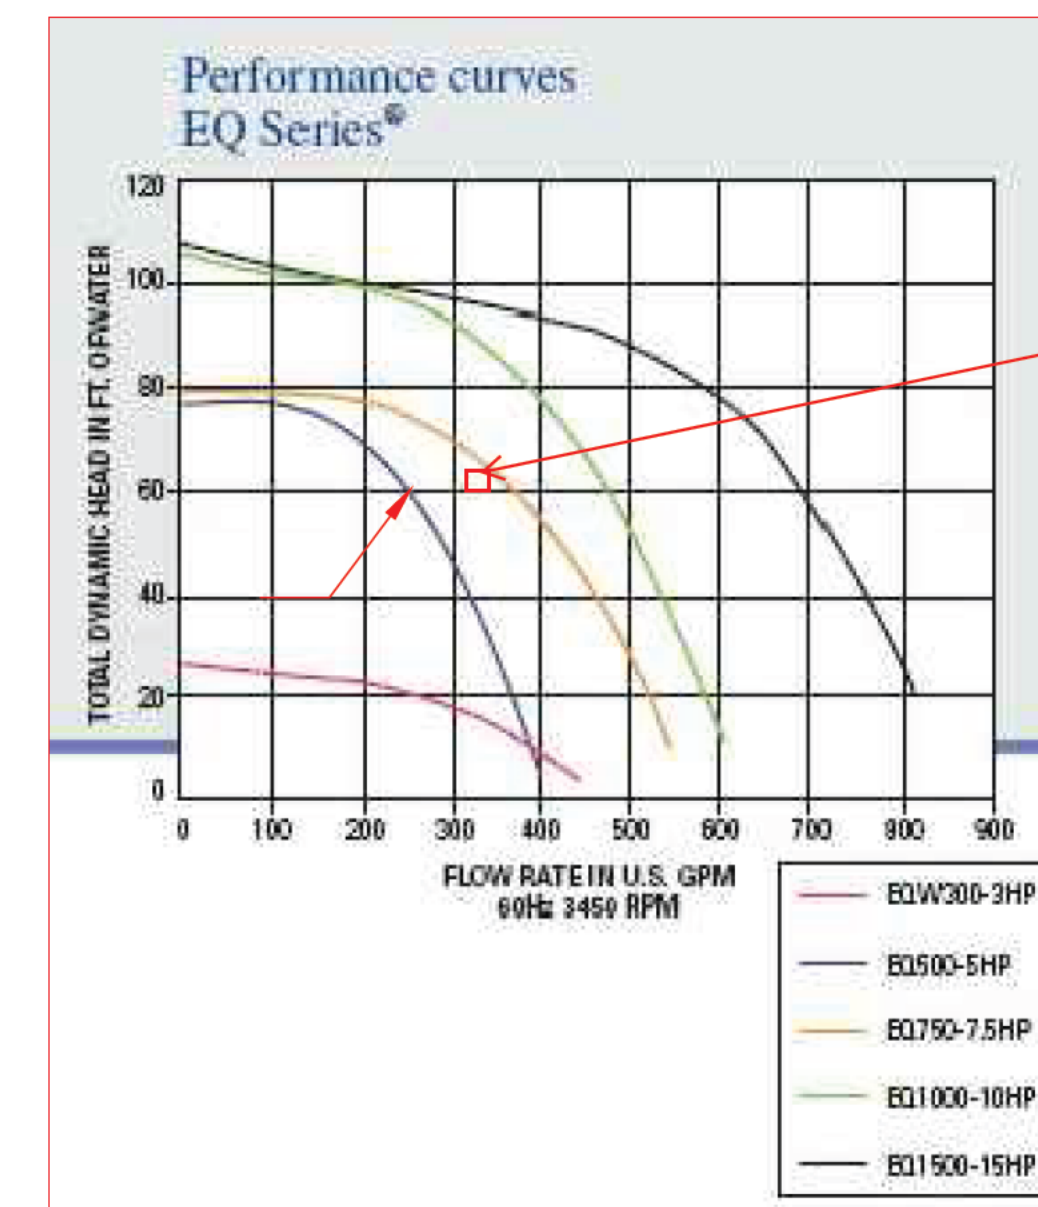
PUMP CURVE

Likely Operating Point at 6-hour turnover

106 GPM is the Max
 4 of these are required for a 6-hour turnover.
 Consider regenerative media filter as alternative.

6 HRS is recommended
 430 GPM
